Manges Cabin Roof Replacement
Summer 2007
Greg Dodson, Hank McCurdy

Start Date: June 4, 2007

Completion Date: July 12, 2007

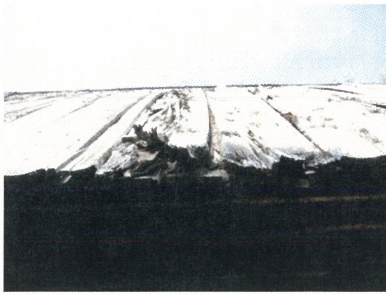
Project details: WCHP first set up scaffolding on the south side of the cabin. On that side, WCHP crew removed the top layer of boards and a layer of 30 lb felt.

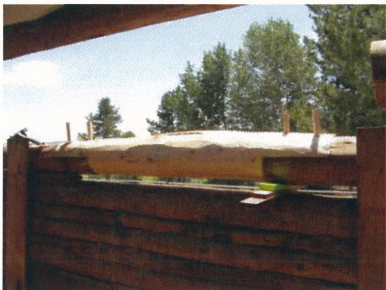
Once the top layer of felt was removed the crew noticed water damage to the bottom layer of boards. The WCHP crew at first only removed damaged boards from the bottom layer, rather than removing all boards as they had done on the top layer. While removing the damaged bottom layer of boards, the crew noticed that there was also deterioration and rot on some of the purlins. Because of the poor condition of the purlins, the crew removed all the bottom boards so that they could

replace two entire purlins that had deteriorated. In addition to replacing two entire purlins, the crew also completed a partial replacement on the lowest purlin.
